The  
CADILLAC

Numbers 1 through 24

January 1 through December 15, 1929

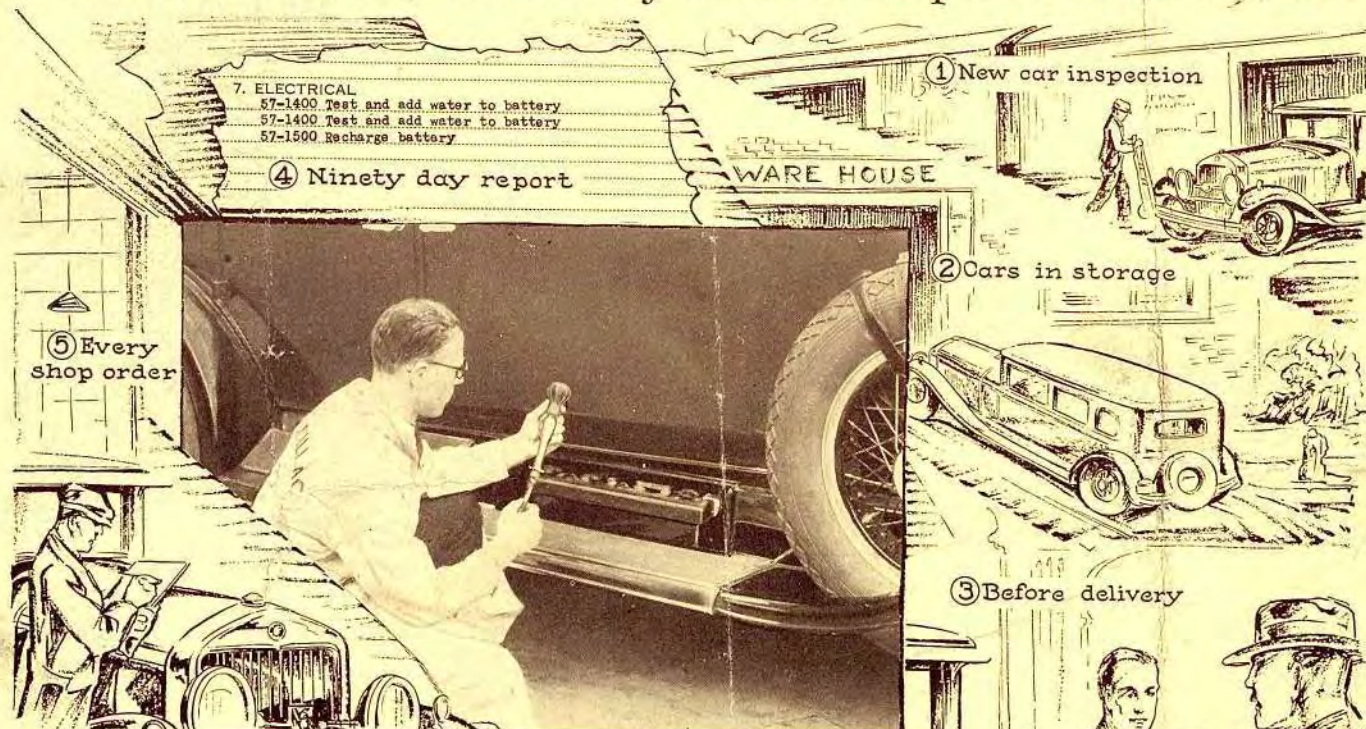
Preventive service on batteries resolves itself into attention on the five occasions shown above. 1. Test the battery when the new car is first received and report the specific gravity on the New Car Inspection Report. 2. If the car is stored the battery should be removed and given proper care during the storage period. 3. Be sure the battery is fully charged before a new car is delivered to the purchaser. 4. Every attention given to the battery during the 90-day period should be included in the 90-Day Report. 5. Check the specific gravity of the battery on every car that comes into the station and write it on the back of the repair order.

Cold weather driving conditions do impose a heavy load on the storage battery, and for this reason some service men take it for granted that there will be a number of battery complaints each winter. These complaints can be largely avoided, however, by the application of thor-

If the specific gravity is 1.250 or above, the battery may be safely assumed to be in satisfactory condition.

If the gravity is between 1.225 and 1.250, look up the specific gravity as recorded at the last regular inspection. If the gravity then recorded was below 1.250, the battery should be removed and charged. If it was above 1.250, the low gravity now is probably a temporary condition, and the generator can be depended upon to bring it up, provided, of course, that the charging rate is normal.

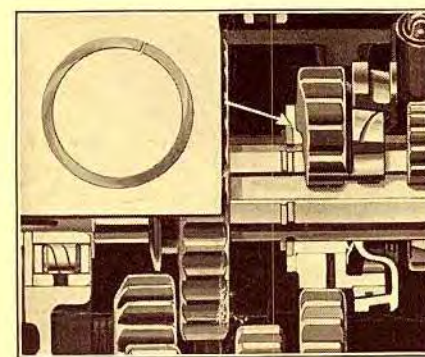
A .010-inch shim, part number 871728, is now available for use between the snap ring and the intermediate gear bushing in the transmission. This shim can be used with any one of the four snap rings to give a finer adjustment of the clearance between the cone on the intermediate gear and its drum.

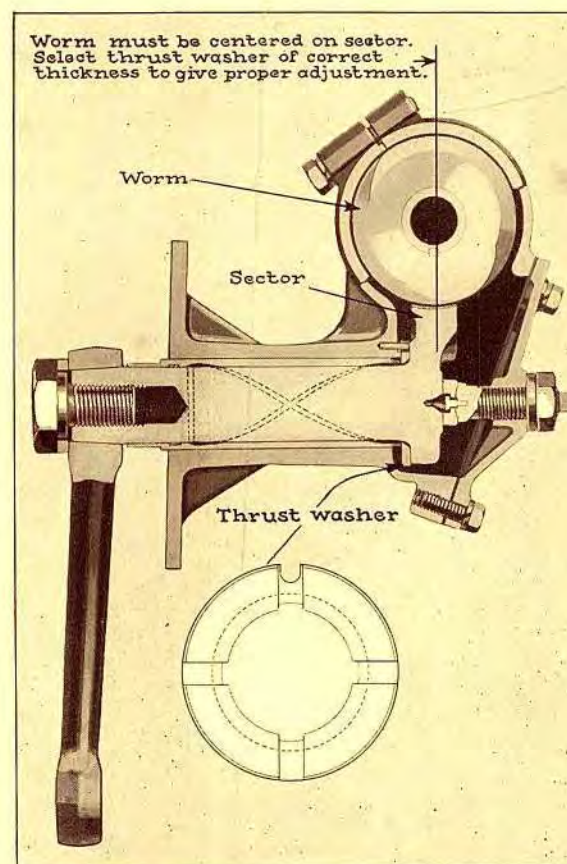
Thrust washers are no longer interchangeable; each washer should be used only with the sector with which it is supplied. Worms and sectors shipped from the factory Parts Division will hereafter include a thrust washer as part of the assembly. The part numbers of these assemblies for cars with left-hand steering are 43343 for Cadillac 341-B and 43342 for LaSalle 328. Thrust washers for replacement will be carried in stock in eight different sizes so that they can be selected to give the proper alignment of worm and sector. These

Thrust washers are supplied in various thicknesses to permit centering the worm and sector

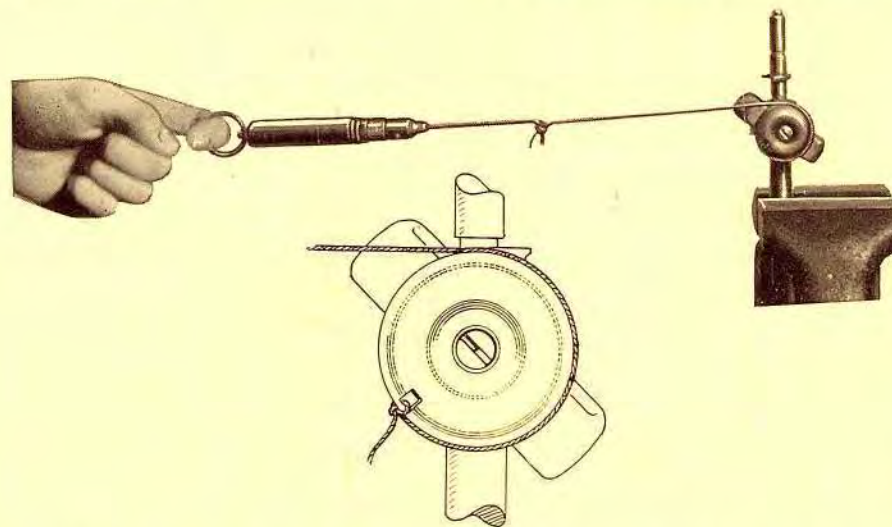
Tie a small flexible wire (such as picture wire) through the hole in the drum that encloses the spring. Wrap this wire around the drum and fasten the loose end to the spring scale used for testing contact point springs (tool number 100242). This set-up is shown in the illustration.

Pull on the scale until the advance pin is drawn to the bottom of the slot in the advance plate. The reading on the scale should then be approximately 4½ pounds. If the reading is higher or lower, the spring tension should be adjusted by loosening the screw and turning the drum to a new position.

To check the tension of the advance governor spring, fasten the wire to the drum as indicated above. The reading on the spring scale should be approximately 4½ pounds

This method is only an approximate test. It does not prove conclusively that the governor characteristics are normal throughout the entire speed range. In case of doubt, the only way is to replace the shaft and governor assembly with one which is known to be standard.

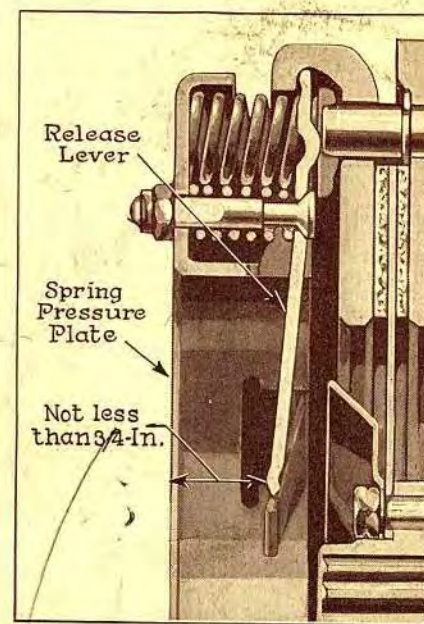
The clutch driven discs should not be replaced if the distance from the rear face of the pressure plate to the nearest point on the release levers is  $\frac{3}{4}$ -inch or more

disassemble the clutch to determine this. Simply place a scale across the rear face of the pressure plate and measure from this scale to the nearest point on the release levers. If this distance is  $\frac{3}{4}$  inch or more, the facing is not worn enough to warrant replacement.

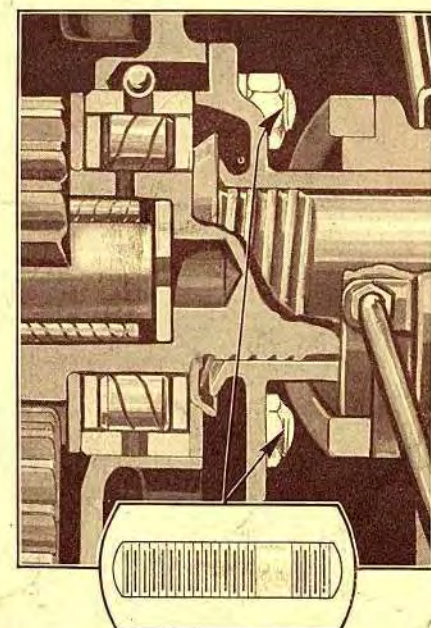
EVERY Cadillac-LaSalle service man knows that, as the clutch facing wears, the clutch pedal rod must be readjusted from time to time to maintain clearance between the release levers or fingers and the release bearing. As each adjustment is made the bearing collar and yoke are moved farther toward the transmission.

In order to permit the bearing and yoke to come farther back, cap screws with special thin heads and special thin lock washers are now used in place of the studs and nuts. This gives the yoke from  $\frac{1}{4}$  inch to  $\frac{3}{8}$  inch increased travel, permitting considerably more wear on the facings before refacing is necessary.

taken to make sure that there is no lost motion between the trunnion and the adjusting nut. If the adjusting nut stands away from the trunnion, the yoke is sure to rest against the studs within a short mileage and thus cause the clutch to slip.

The studs and nuts for the clutch connection bearing shown at the left have been superseded by the cap screws shown at the right. When used with the special thin lock washers, the cap screws allow approximately  $\frac{1}{4}$ -inch additional travel for the clutch release yoke

The cap screws are interchangeable with the studs and can be installed upon removing the studs. The screws should be dipped in white lead before installing, to prevent leakage of lubricant from the transmission.

2. *When the clutch pedal adjusting nut stands away from the trunnion.* The transmission should be removed and the studs should be replaced with the cap screws and special thin lock washers.

3. *If the clutch has already started to slip.* In this case remove the transmission and replace the studs with cap screws and thin lock washers.

4. *Whenever a transmission is removed for any purpose.* In this case, always replace the studs with the cap screws and special lock washers.

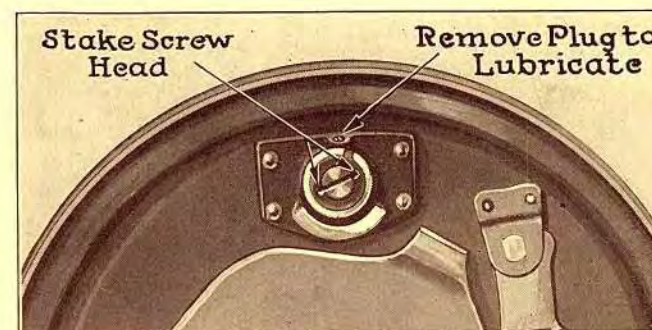
Lubricant should be added to the front brake trunnions every 4000 miles. While the wheels are off, the flat-headed screw in the end of the trunnion should be inspected to see that it is properly staked as shown

If any screws are found that are staked only in one place, they should be re-tightened and staked at both ends of the slot. A center punch is used to stake the screws.

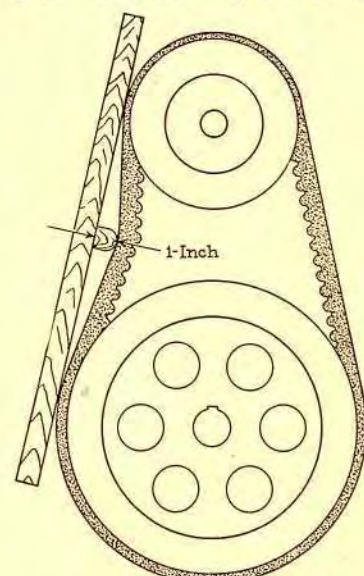
It has been found advisable to lessen the tension on the fan belt. Hereafter all fan belts should be set as shown above, instead of the  $\frac{3}{8}$ -inch setting given in the Apr. 1 SERVICE MAN.

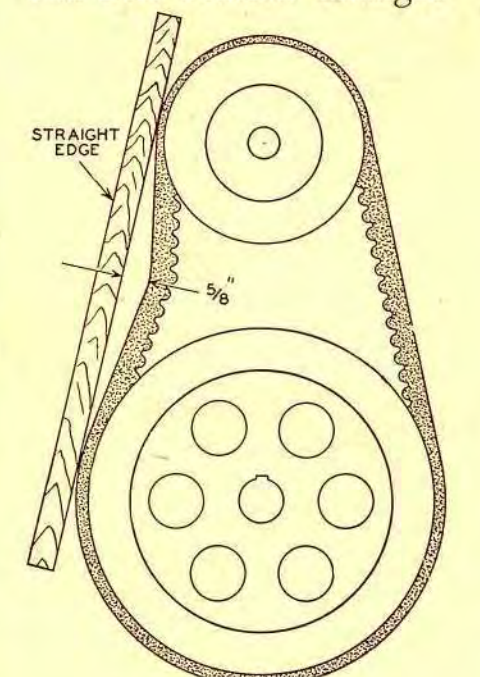
A change in the fan belt adjustment, increasing the amount of slack from  $\frac{5}{8}$  inch to 1 inch, was announced in the February 1 SERVICE MAN. The previous recommendation of  $\frac{5}{8}$  inch is once more in force, as the belts slip too much at high speed when adjusted with 1 inch slack.

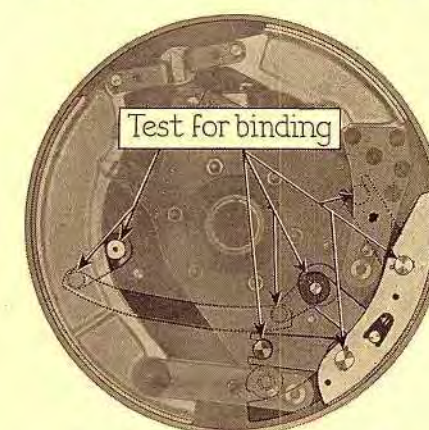
Insufficient release or binding of guide pins or connections may cause hand brake shoes to rattle

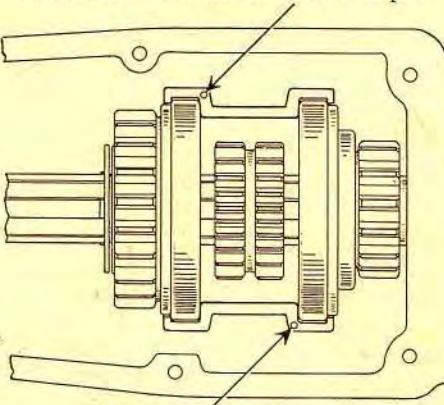
Guide blocks should always be installed in 353 and 340 transmissions with the "O" marks in the positions shown in this diagram

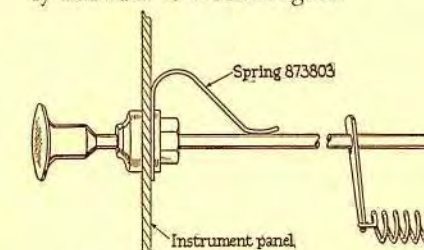
This new spring (873803) prevents the choke control from returning to position immediately. Whenever it is installed, the tension on the coiled pull-back spring should be decreased.

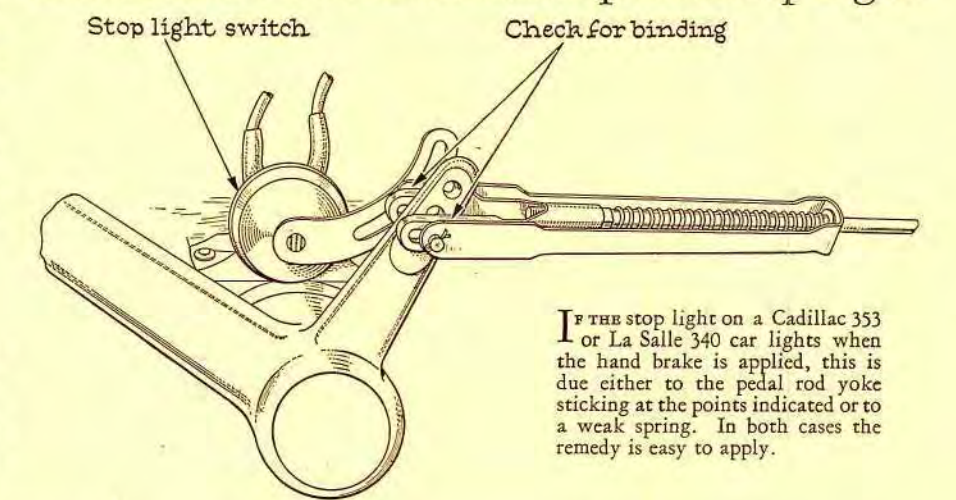
If the stop light on a Cadillac 353 or La Salle 340 car lights when the hand brake is applied, this is due either to the pedal rod yoke sticking at the points indicated or to a weak spring. In both cases the remedy is easy to apply.

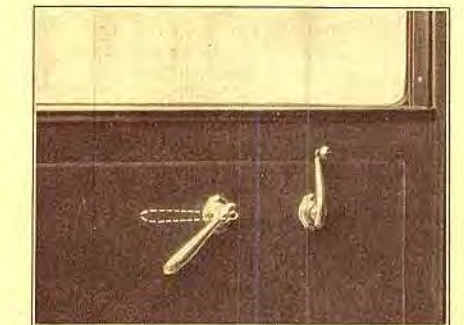
THE remote control handle for the left front door of Cadillac 353 sedans has formerly been installed at an approximate angle of 45°, as shown above. This position makes it possible for the driver to catch the cuff of his coat sleeve on the handle when making a sharp turn to the left. On this account the handles are now being assembled at the factory in a horizontal position, as indicated by the dotted line. This change can also be made in service where desired by simply loosening the flat hexagonal nut back of the handle and re-setting the handle in the proper position on the serrated shaft.
