The CADILLAC SERVICEMAN

Volume XVI, Number 1

January-February, 1942

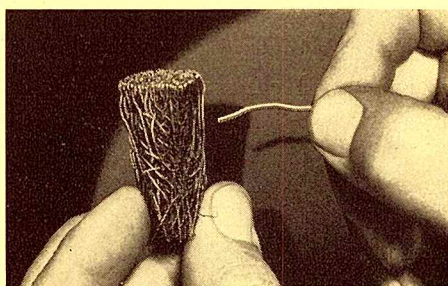
Insert curved wire through filter before installing filter in drain tube

Installation of the filter assembly is accomplished by inserting the wire spring retainer through the cartridge until the ends of the wire protrude about $\frac{1}{8}$ " from each side, as shown in the illustration.

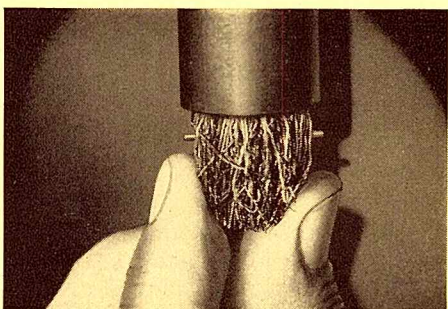
The filter may be easily inserted in the drain tube by pinching the tube slightly

Then filter and retainer are pushed up into the end of the drain tubing with the ends of the wire retainer curved downwards so as to engage the sides of the rubber drain tubing.

The filter should be pushed up far enough to clear the end of the drain by approximately $\frac{1}{2}$ ". It may be necessary to pinch the rubber tubing slightly 90° from the retainer wire ends to permit installation.

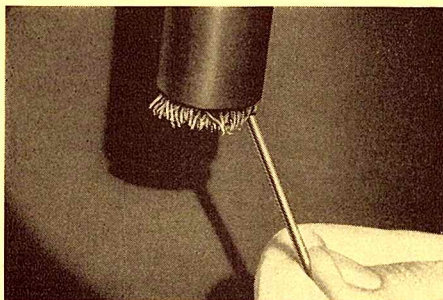
The filter may be removed from the tube by a hooked rod

removed to clean silt or sediment from the drain tubing, this can be done by inserting a hooked wire between filter and inside of drain tubing and pulling filter out.

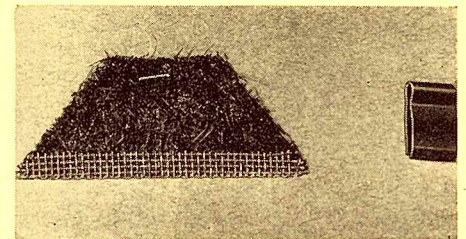
The door drain filter is triangular in design and is held in place by a retainer clip

Installation is made by pinching the retainer clip onto the center of the wide bottom edge of the filter.

Then with the screen side of the filter toward the inside of door, insert the filter up into the drain hole so that the clip engages the lip of the drain outlet, as shown in the illustration. Install filter so that its lower edge is flush with the bottom edge of the drain, otherwise it might be obstructed by the door bottom weather-strip.

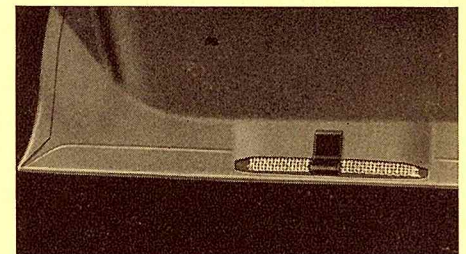
When properly installed the filter should be flush with the bottom edge of the drain

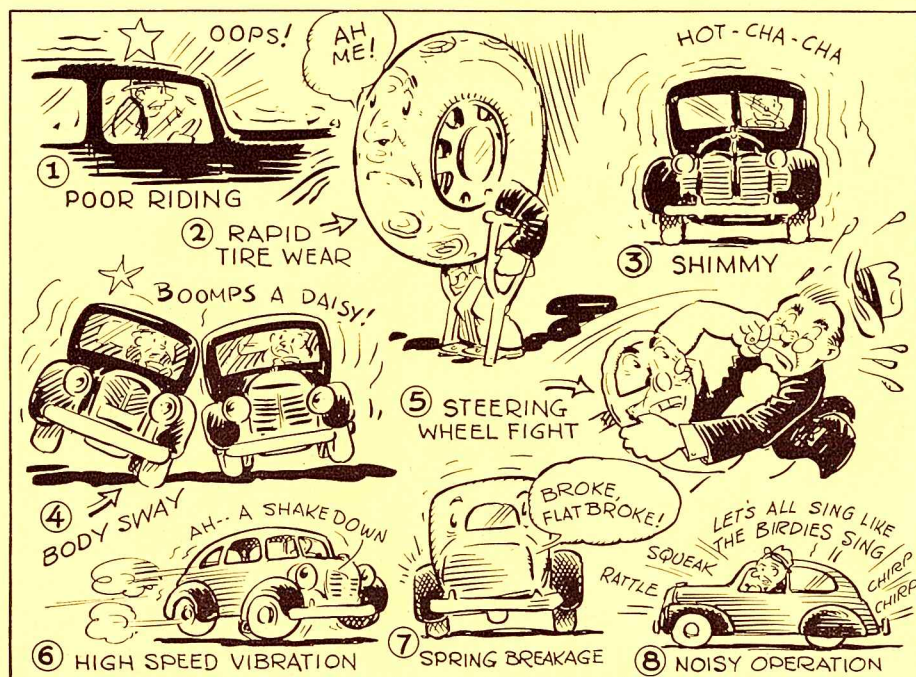
2. Excessive Tire Wear: Rear wheels bouncing or dancing over bumps spin while in the air, causing the rubber to scuff when they again contact the ground. There is also a loss of traction, resulting in lower gas mileage.

3. Front Wheel Shimmy: Broken or inoperative shock absorbers increase front wheel shimmy and wheel tramp which is annoying and dangerous.

6. High Speed Vibration: High speed vibration is caused by the wheels leaving the ground, which builds up oscillation and results in terrific vibration at high speeds.

Illustrated above are eight ways in which improperly functioning shock absorbers can shorten car life and cause discomfort to passengers.
