The  
CADILLAC

Numbers 1 through 24

January 1 through December 15, 1929

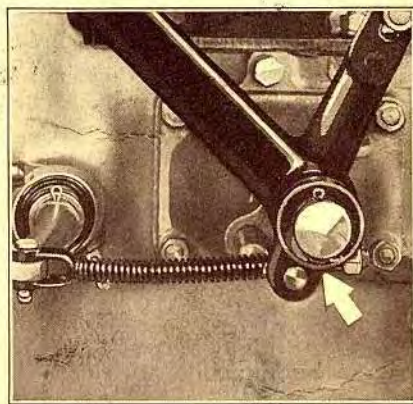
When the point of interference between the yoke and studs on the earlier cars is reached, it is useless to adjust the nut on the clutch pedal rod. Unscrewing this nut simply backs it away from the trunnion and, while the pedal may have the required one inch free travel, it does not mean anything because the yoke is as far back as it can go.

When checking the clutch pedal adjustment, make sure that the adjusting nut is tight against the trunnion

taken to make sure that there is no lost motion between the trunnion and the adjusting nut. If the adjusting nut stands away from the trunnion, the yoke is sure to rest against the studs within a short mileage and thus cause the clutch to slip.

2. *When the clutch pedal adjusting nut stands away from the trunnion.* The transmission should be removed and the studs should be replaced with the cap screws and special thin lock washers.

3. *If the clutch has already started to slip.* In this case remove the transmission and replace the studs with cap screws and thin lock washers.

4. *Whenever a transmission is removed for any purpose.* In this case, always replace the studs with the cap screws and special lock washers.

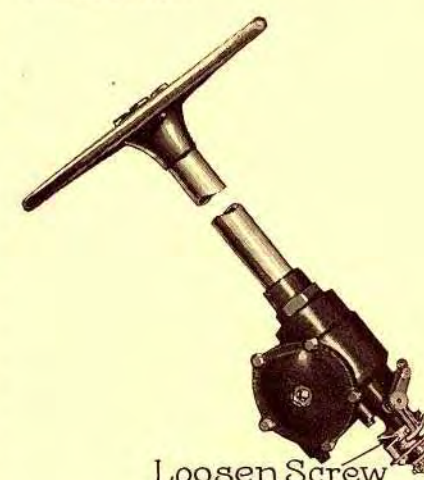
The usual method of removing the horn switch is to drop the side pan and remove the lighting switch so that the switch tube and lever can be turned and pulled up far enough to expose the retaining screw for the switch button.

To remove the horn button, loosen the clamp screw and turn the stationary tube counter-clockwise until the lighting switch tube can be pushed up enough to give access to the retaining screw

Mr. Griffin states that from one-half to three-quarters of the time ordinarily required to do this can be saved by his method. Instead of removing the side pan and switch, he simply loosens the clamp screw on the lower end of the steering gear housing. He can then turn the stationary tube counter-clockwise until the lighting switch lever and tube are released, when the tube can be pushed up far enough to give access to the horn switch retaining screw.

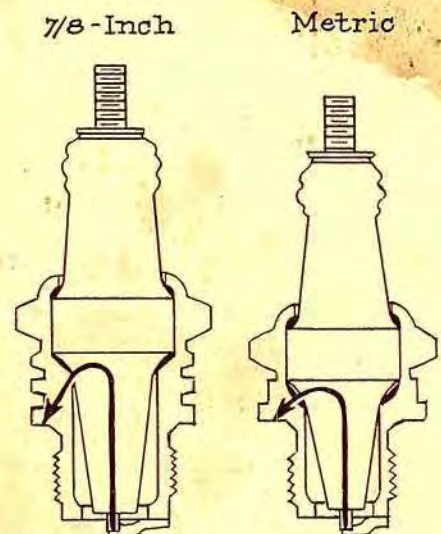
AS PREVIOUSLY announced, 18 millimeter-metric spark plugs, A.C. Type G-10, are now used on Cadillac and LaSalle cars in place of the  $\frac{7}{8}$ -inch S.A.E. standard plug. This change was made because the metric plug, being smaller in diameter, is more efficiently cooled and is thus enabled to stand higher engine speeds and higher compression without overheating and possible pre-ignition.

The metric spark plug cools more rapidly than the  $\frac{7}{8}$ -inch plug, because a smaller area is exposed to the heat, while the seat through which the heat is transferred to the cooling water remains practically the same.

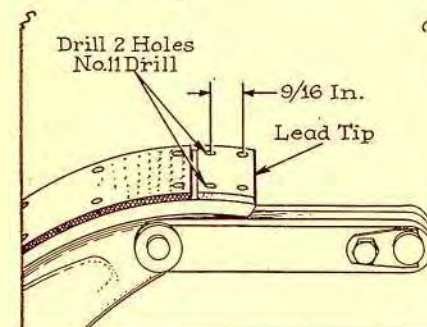
In order for the tips to function properly, their outer surface must be even with the frictional surface of the brake lining. New tips must therefore be installed whenever the linings are replaced. Regular lining rivets are used to install the tips.

When brake shoes which were not originally equipped with the lead tips require re-lining, these tips can then be installed. To do so, it is merely necessary to drill two additional holes in each shoe as indicated in the drawing.

When brake shoes, which originally were not equipped with lead tips are being relined, the tips can be installed by simply drilling the two holes shown above.

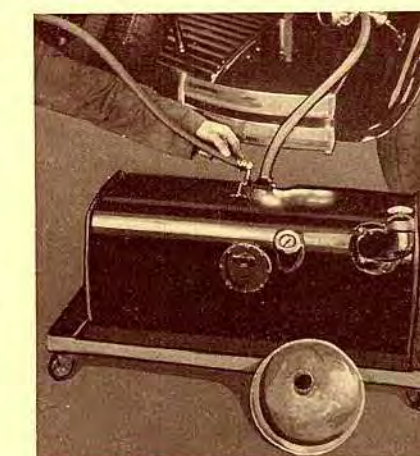
This portable tank and funnel (foreground) simplifies the job of testing gasoline gauges and draining gasoline tanks for repair work on gauges.

To check the gauge on a car, jack the car up far enough to permit the measuring tank to be rolled in under the drain plug on the car. Use the funnel in the filler neck of the measuring tank and drain the gasoline into the measuring tank, a gallon at a time, checking the gauge on the car at each interval.

By the time the tank is emptied, the accuracy of the gauge will have been checked at all points, and any repairs or replacements necessary on the gauge can be made while the tank remains empty.

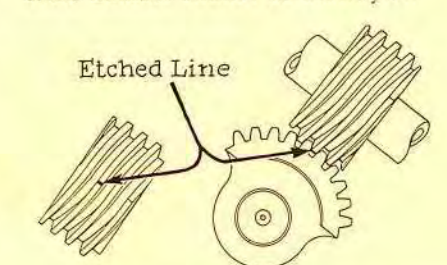
These markings now appear on worms and sectors supplied by the Parts Division. They indicate the proper way to mesh these parts when installing them

## Worms and Sectors Marked For Correct Installation

Second, when installing the sector, turn the worm so that the mark which is etched across one of the threads points toward the sector. Then install the sector with this thread in the center space of the sector.

Some of the worms shipped since April 25 do not have the etched mark referred to in the preceding paragraph. In such cases turn the worm so that the keyway points up and then mesh the center thread on the worm with the center space on the sector.

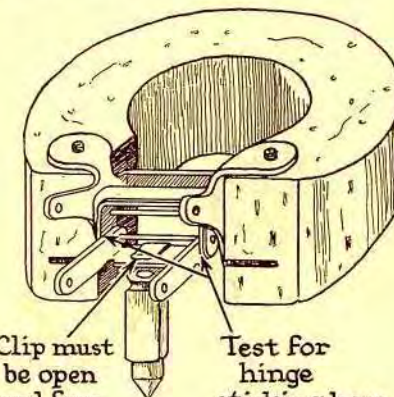
THERE ARE occasional instances of cutting out at high speeds apparently caused by faulty ignition, which in reality are due to the carburetor float hinge sticking.

There are several possible causes for this condition. It most frequently occurs in that part of the hinge to which the needle valve clip (53073) is hooked. This part may bind between the sides of the lower part of the hinge. (See illustration.)

Clip must be open and free

Test for hinge sticking here

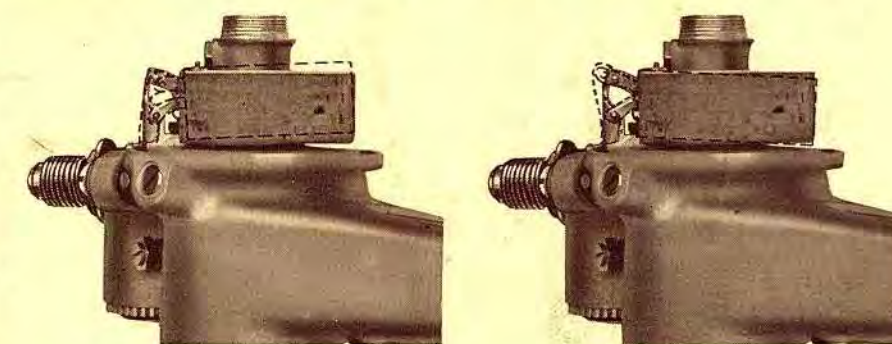
Bend the hinge bracket in to lower float (left) and out to raise the float (right). In these views the carburetor is upside down, as it would be for working on the bench

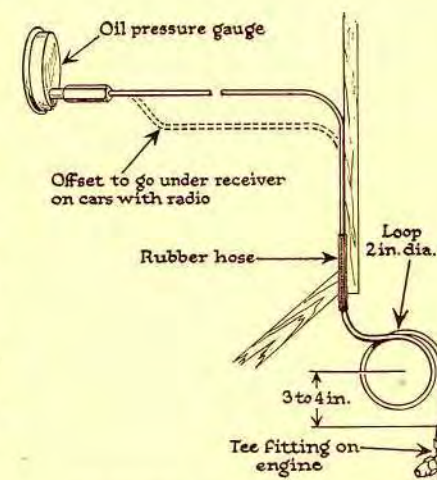
Oil pressure gauge pipes on 353 and 340 cars must have this loop between the dash and the engine

Re-install the pipe, bending it as necessary under the cowl and moving the clips to new positions on the pipe.

It is also important to protect the pipe from being chafed by the dash or the toe-board. A piece of rubber tubing is used at this point on cars

now being shipped, and should be installed on cars in service when the loop is made in the pipe.

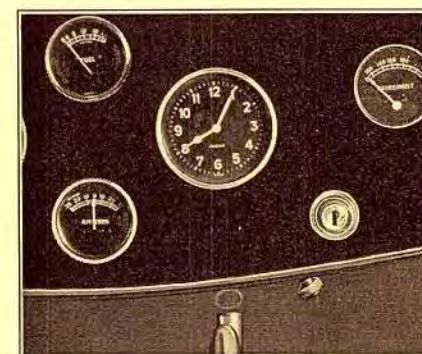
THE STEMS of the clocks on the La Salle 340 instrument boards have formerly projected straight down. The knurled knob of the clock stem has thus projected down to within a very short distance of the top of the hand brake lever.

While the hand brake lever can be operated without interference from the knob of the stem, the knob will interfere if the lever is grasped with the thumb over the top of the handle.

The new winding stem for La Salle 340 clocks is located further to the right so that it will not interfere with operation of the hand-brake lever

On this account, the clock stem has been lengthened and moved around so that it projects down from the clock at a 30° angle which brings it approximately two inches to the right of the brake lever.

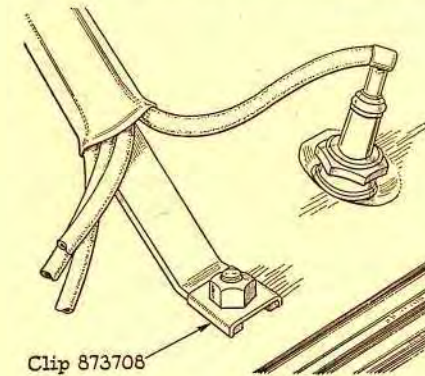
A MINOR improvement recently made in Cadillac 353 and La Salle 340 engines is the use of a new clip, part number 873708, under the hold-down nuts for the ignition conduit support. This clip is bent over on the ends in such a manner that it keeps the forked ends of the conduit

Clip 873708  
If the stud is not long enough to show one full thread above the nut when the clip is installed, a longer stud, 873788, should be used.

support from spreading when the nuts are turned down tightly.

On some cars the cylinder head studs to which the conduit base is fastened will be a little too short to permit installing the clips. It will then be necessary to replace the studs with stud 873788, which is of sufficient length to permit easy installation.

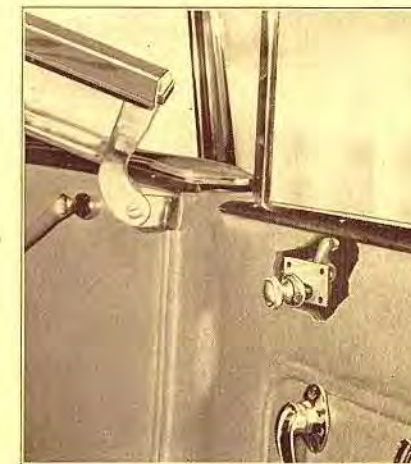
The first of these improvements was made to assure a completely water-tight joint between the bottom of the center post and the body. It consists of a bracket fitted with a strip of sponge rubber, fastened to the bottom of the center post. When the center post is up, the sponge

THE RAIN bracket at the bottom of the center post and the anti-rattler for the door glass are two new features of the Fleetwood All-Weather Phaeton.

rubber is compressed with sufficient tension to form a leak-proof joint.

These brackets can be installed in a short time on any All-Weather Phaeton which shows a tendency to leak at this point. They can be secured
